# Main Bearing Monitoring

How VSB took action in the main bearing with minimum impact

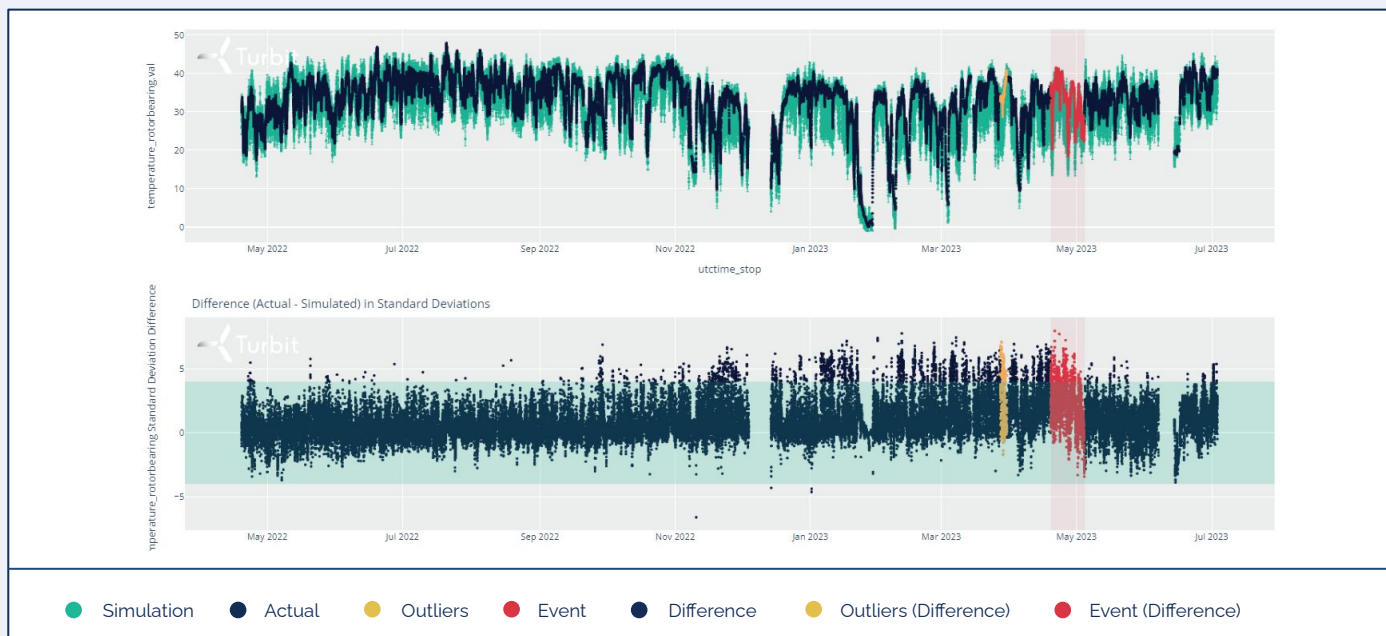
Upon detecting a change in the normal behavior of the wind turbine in April 2023, Turbit's monitoring system promptly identified an anomaly. Through our analysis, a consistent upward trend in the main bearing temperatures was observed, especially noticeable since spring/summer 2022. This trend raised concerns as it indicated a potential damage in the main bearing.

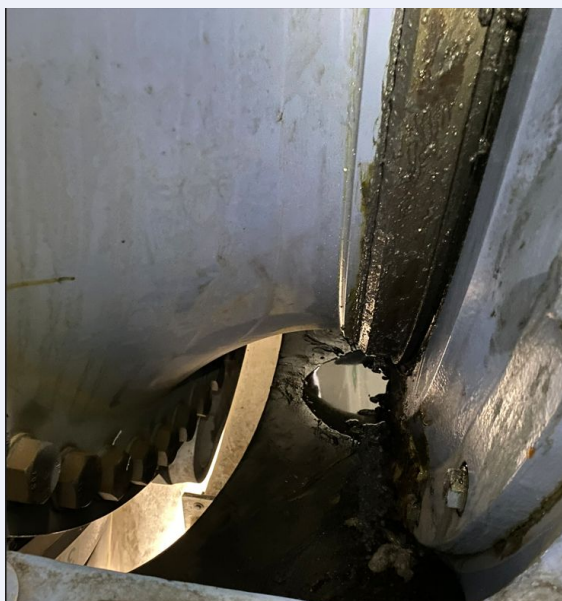
Recognizing the importance of collaboration, discussions were initiated. VSB informed Turbit about a recent inspection where black grease was discovered in the turbine main bearing without a clear explanation. This physical evidence, coupled with the temperature trends, indicated an underlying technical issue that required immediate attention. Simultaneously, VSB communicated the issue to the original equipment manufacturer (OEM) responsible for the wind turbine.

With the physical evidence and temperature data in hand, the collaboration with the OEM was satisfactory. Within a week, the OEM responded, expressing their commitment to resolving the issue promptly. They devised a plan to retrieve a sample of the grease for thorough analysis and to grease the main bearing as soon as possible

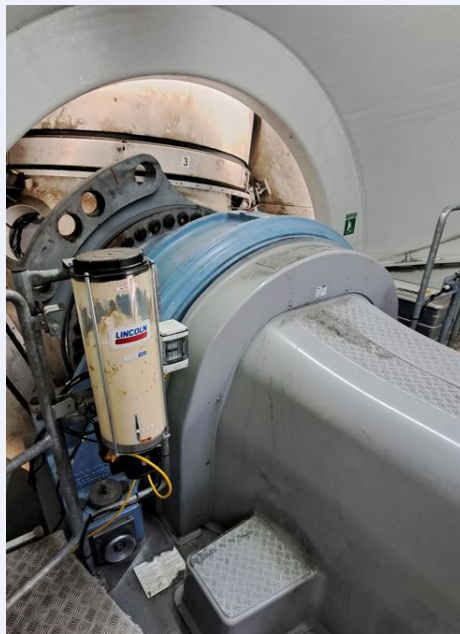
The greasing operation performed on May 3rd proved instrumental in mitigating the issue. The subsequent decrease in temperatures confirmed the positive impact of the greasing procedure. Additionally, to ensure continuous lubrication, the OEM installed additional grease pumpings in the wind turbine.

Since the implementation of the solution, the wind turbine has been operating within expected temperature ranges. This achievement is a testament to the collaborative efforts between VSB and the OEM. Nevertheless, monitoring continues to identify any potential damage caused by prolonged exposure to higher temperatures than optimal.
