Generator Monitoring

How Energiequelle solved a damage in the generator

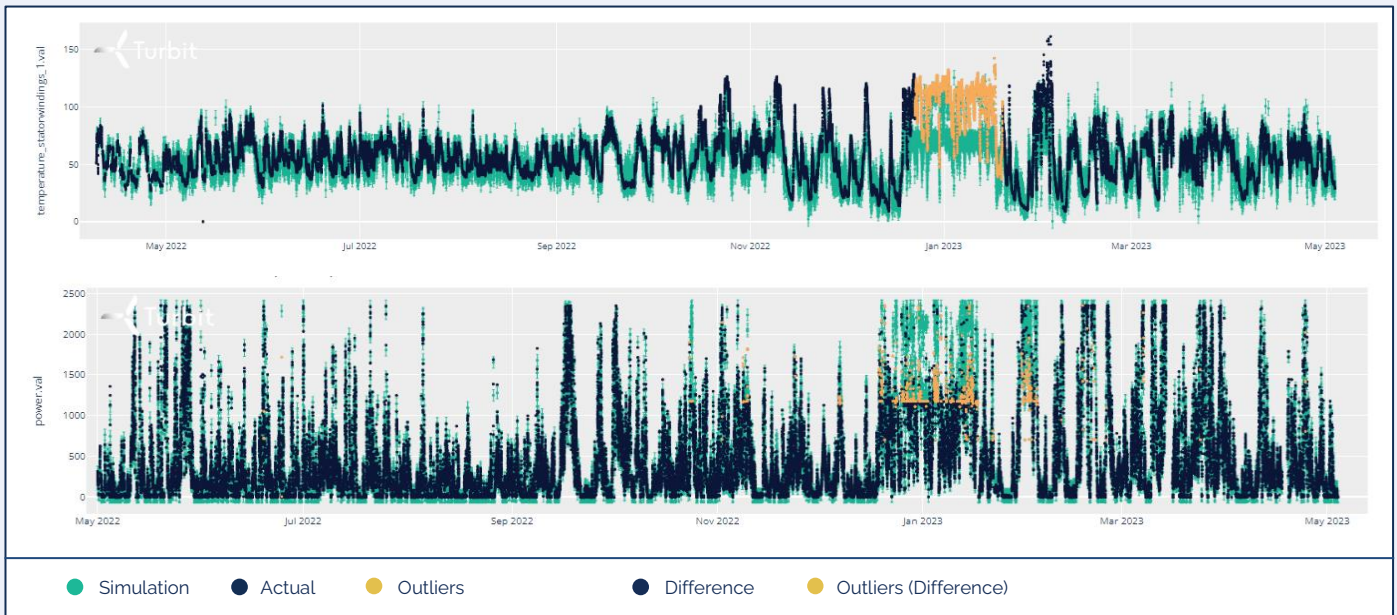
On October 24th, 2022, an initial temperature increase was detected in the stator windings of the generator of one of SAB's wind turbines under the operation of Energiequelle, indicating an alteration in the turbine behavior. Turbit's alarm system identified the anomaly and raised the alarm.

In addition, the turbine's output intermittently varied between 2300kW and 1185kW since October 24th and was continuously throttled to 1185kW from December 19th, 2022 on.

Energiequelle investigated the issues behind this anomaly and revealed that a malfunctioning frequency converter led to elevated temperatures. Energiequelle sent this analysis to the service partner, and the replacement of the faulty frequency converter was scheduled.

On February 7th, the Service Partner replaced the frequency converter. The temperatures returned to their normal range immediately after the converter exchange. No subsequent incidents have been reported and the turbine has been operating at rated power without any anomaly.
